FOLDING TOP ADJUSTMENTS—"B & C" Body

DESCRIPTION

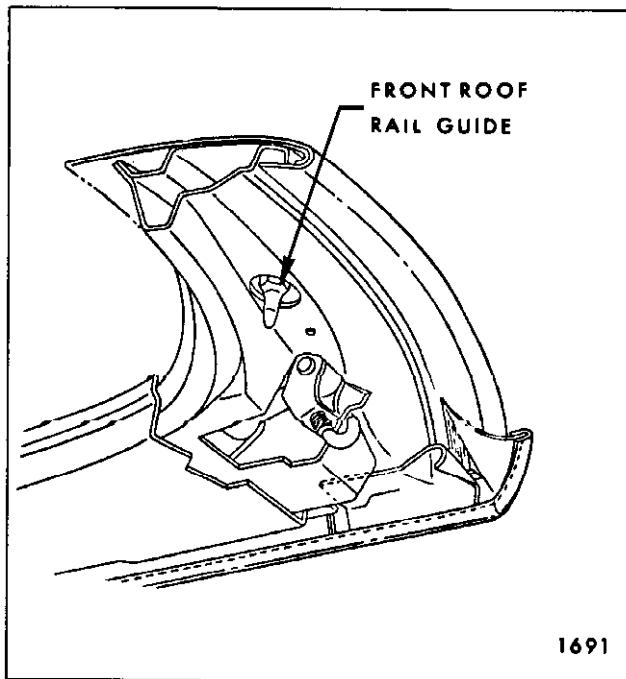
Fig. 13-79 - Guide Adjustment

1. Raise top assembly to half-open position.
2. Loosen guide sufficiently to permit adjustment (Fig. 13-79).
3. Shift guide to desired position; then tighten guide.

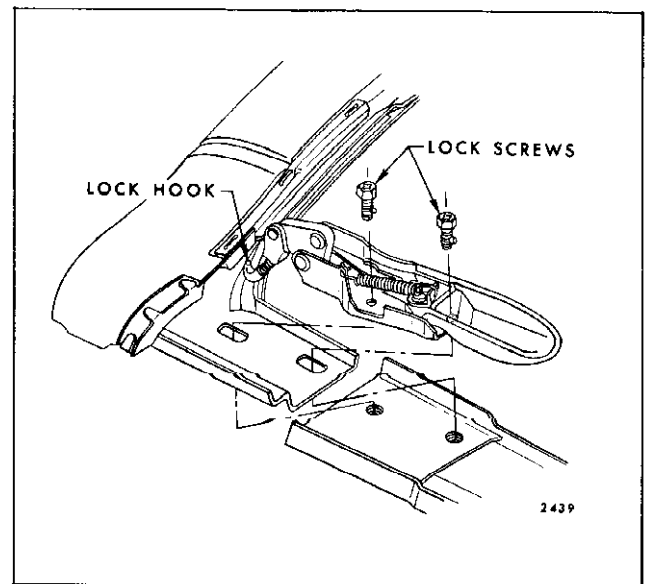
Fig. 13-80 - Lock Attachment

1. Unlatch top and raise it above windshield header. Remove side roof rail weatherstrip front attaching screws.
2. Loosen side roof rail lock attaching screws and adjust front roof rail fore or aft as required. Repeat on opposite side if necessary (Fig. 13-80).

1. Unlock top from windshield header.
2. With top in a half-open position, remove lock attaching screws; then, remove lock assembly from front roof rail (Fig. 13-80).
3. To install, reverse removal procedure.

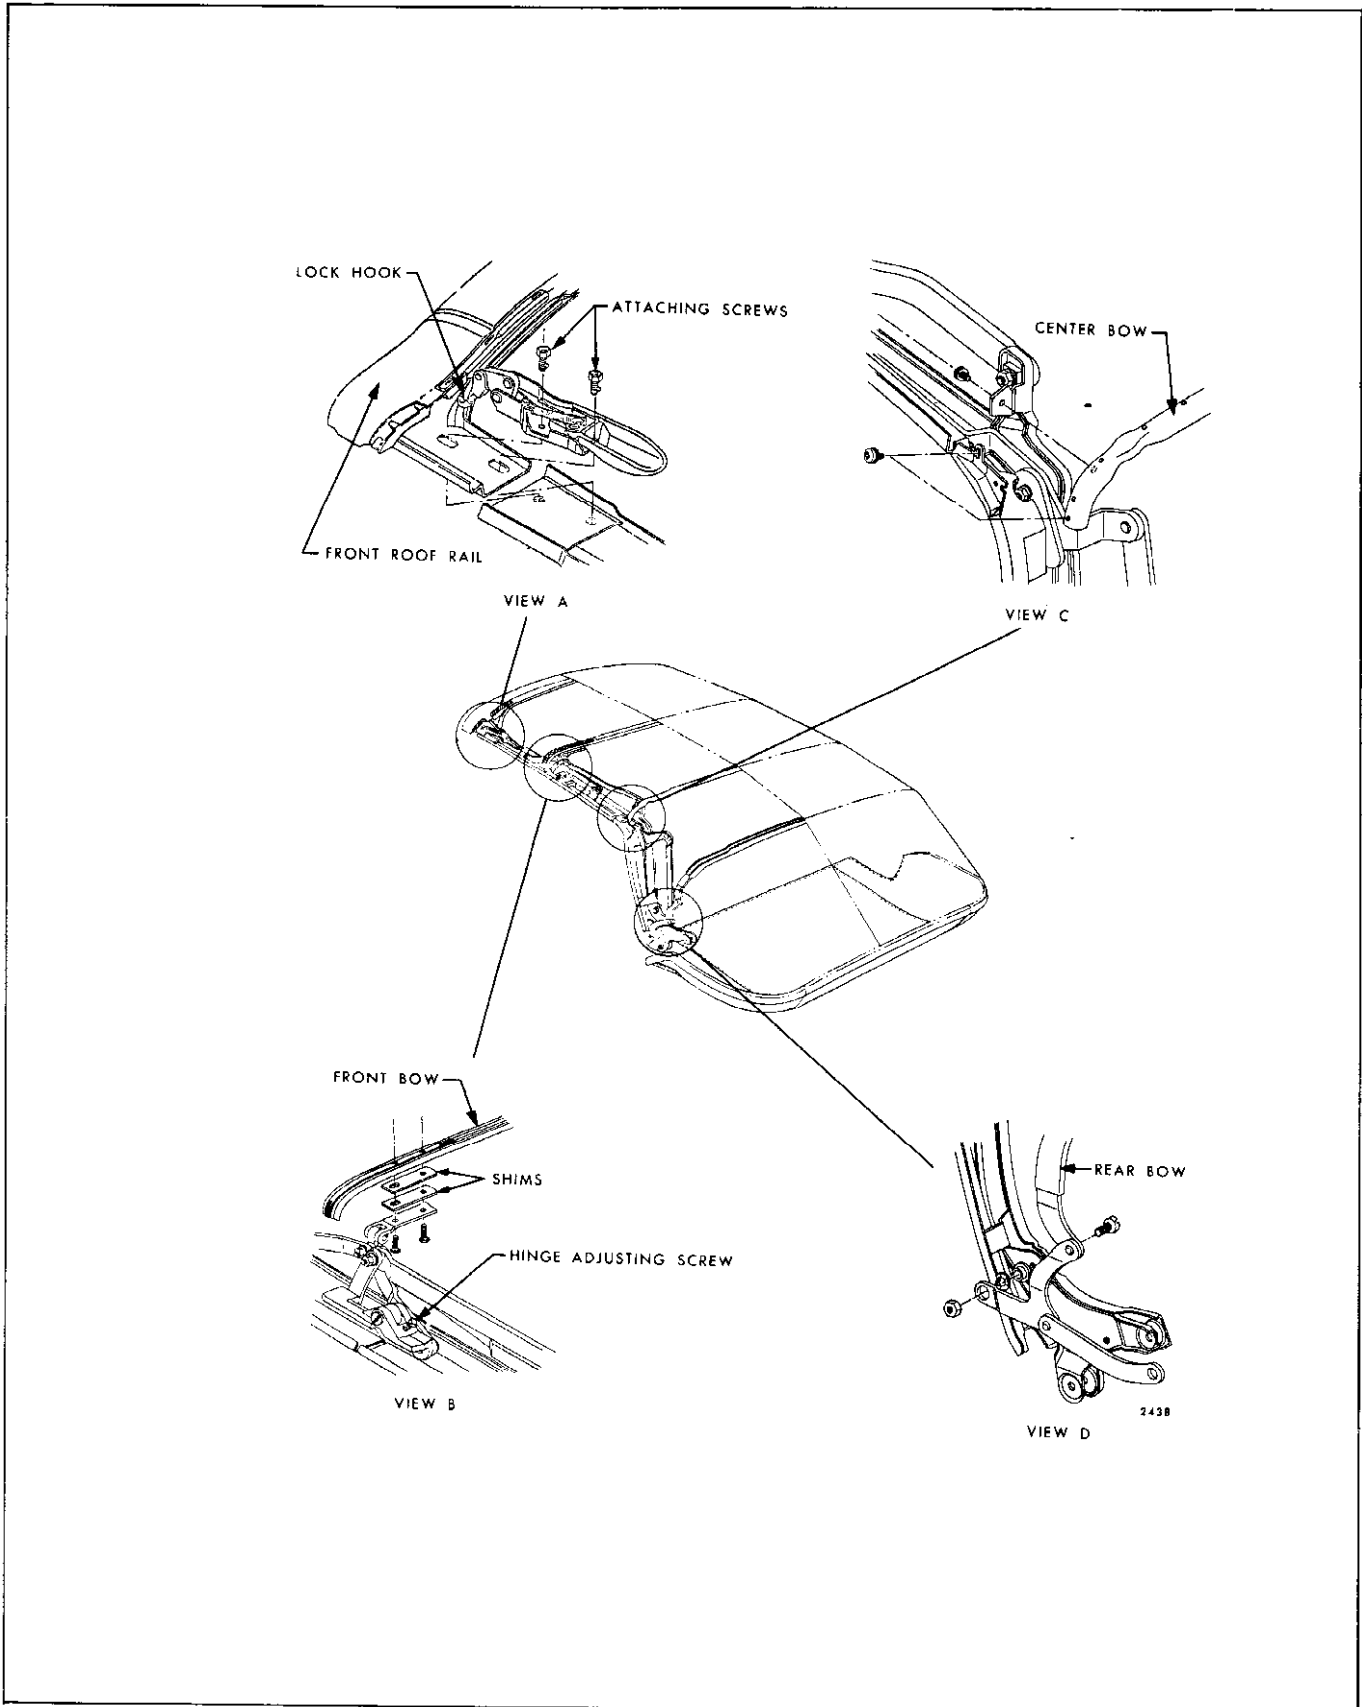
Fig. 13-82 — "B and C" Body Folding Top Adjustments

| CONDITION | APPARENT CAUSE | CORRECTION |
|---|--|---|
| C. Top travels too far forward. | <ul style="list-style-type: none"> 1. Front roof rail misaligned. 2. Male hinge assembly misaligned. | <ul style="list-style-type: none"> Adjust front roof rail rearward (Fig. 13-82). Adjust male hinge assembly rearward (Fig. 13-81). |
| D. Top does not travel forward far enough. | <ul style="list-style-type: none"> 1. Front roof rail misaligned. 2. Male hinge assembly misaligned. | <ul style="list-style-type: none"> Adjust front roof rail forward (Fig. 13-82). Adjust male hinge assembly forward (Fig. 13-81). |

| CONDITION | APPARENT CAUSE | CORRECTION |
|--|--|--|
| | 2. Center side roof rail hinge adjusting screw improperly adjusted. | Adjust screw counterclockwise (Fig. 13-82). |
| | 2. Center side roof rail hinge adjusting screw improperly adjusted. | Adjust screw clockwise (Fig. 13-82). |

| CONDITION | APPARENT CAUSE | CORRECTION |
|---|---|---|
| <p>M. Top material is too low over windows or side roof rails.</p> | <ol style="list-style-type: none"> 1. Front roof bow improperly shimmed. 2. Excessive width in top material. | <p>*Install one or two 1/8" shims between front roof bow and slat iron (Fig. 13-82).</p> <p>If top is too large, detach binding along affected area, trim off excessive material along side binding as required; then hand sew binding to top material.</p> |
| <p>N. Top material is too high over windows or side roof rails.</p> | <ol style="list-style-type: none"> 1. Front roof bow improperly shimmed. | <p>*Remove one or two 1/8" shims from between front roof bow and slat iron (Fig. 13-82).</p> |
